P. Greyling¹, R. Rontgen¹, G. Rebel² and B. Schmitz²

Premature discard of 45 mm ropes operating on a Blair Multi-Rope

rock winder

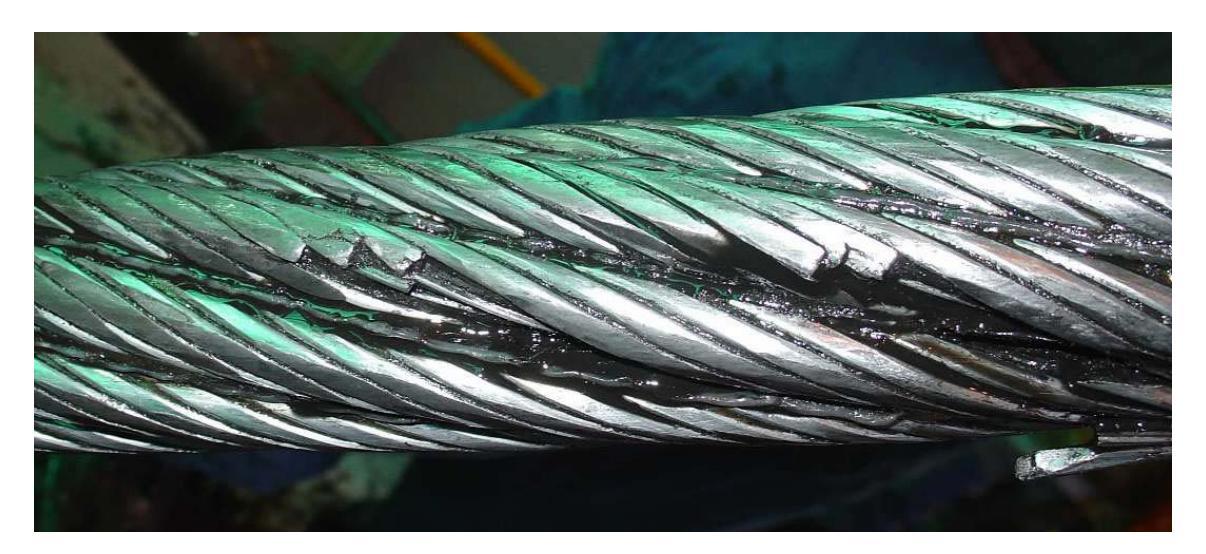
The mine was offered a rope life guarantee of 165,000 cycles (2.5 times the average TSR life on the winder). During a routine magnetic test of the ropes on 30 May 2006, the damage shown in Figure 8 was found on rope No. 1 (see Figure 2c) and a number of broken wires were found in the same position on rope No. 2. At this stage the winder had completed 35,000 cycles since the ropes were installed end September 2005. The rope manufacturer was present during the magnetic testing and a decision was made to immediately remove ropes 1 and 2 from the winder and replace them with a spare set of triangular strand ropes. Ropes 3 and 4 did not show any damage at that time.

Figure 8: First broken wires found on rope No. 1 on 30 May 2006 on bottom drum layer, 12 turns from drum flange / 1st layer crossover. This damage is in the Section B/B, see Figure 9.

At the time of discard of ropes 1 and 2 it was assumed that the reason for the damage shown in Figure 8 related to interaction between the rope and the drum coiling sleeves. Tight drum grooves were found on parts of the drums at the time of rope installation in September 2005.

In discussions between the mine and rope manufacturer, it was also agreed that 150 m should be cut off the skip ends of ropes 3 and 4 so that what were dead turns in Section B became live turns (see Figure 9). The objective was to move the acceleration region and increase the lifetime of ropes 3 and 4 assuming that they were suffering from the same damage mechanism as ropes 1 and 2. The cuts on ropes 3 and 4 were made and the next magnetic tests scheduled for 20 June 2006.

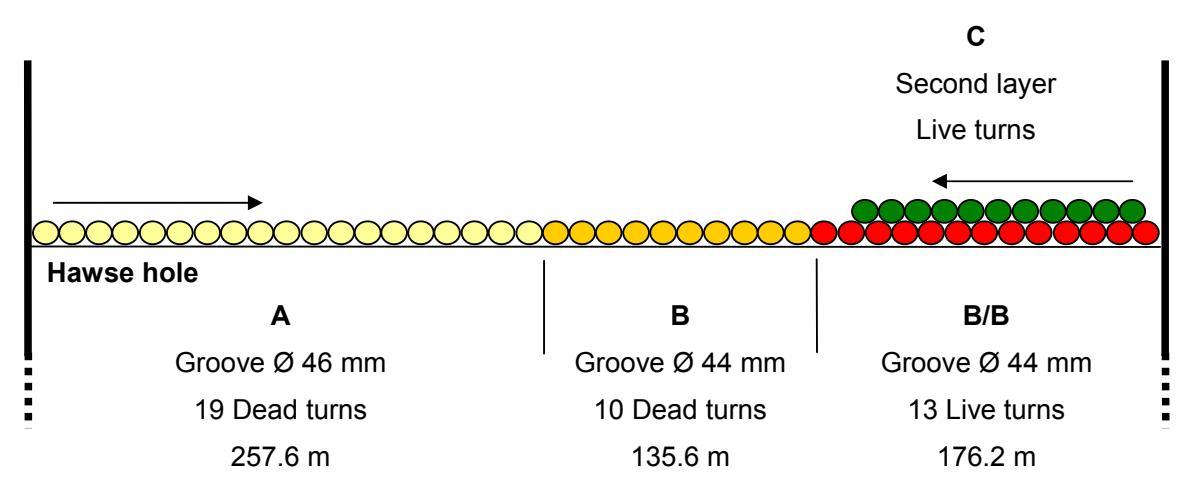
Rope samples including areas with broken wires were sent for examination to both the rope manufacturer and the Council for Scientific and Industrial Research laboratories in Johannesburg. In both cases pieces were cut from Sections A, B, B/B and C as indicated in Figure 9.

Figure 9: Discarded rope sections relative to drum coiling positions at rope installation, total rope length on drum bottom layer is 569 m, 42 turns.

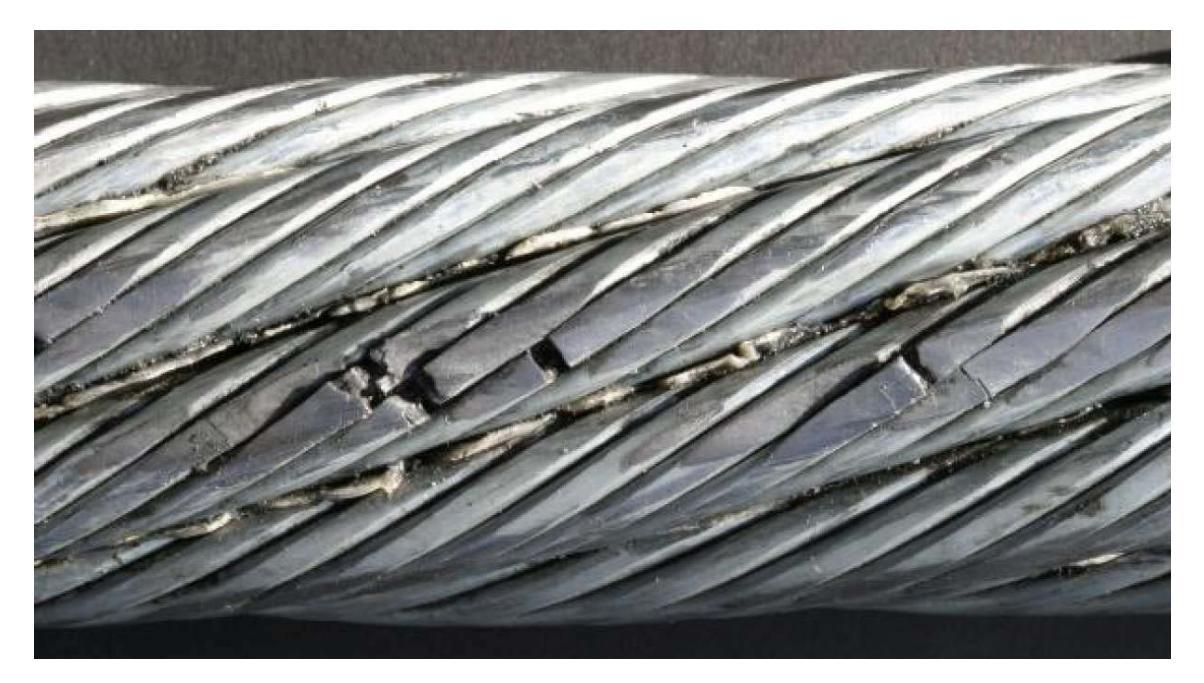
Figure 11: Typical damage found in Sections A and B, at discard.

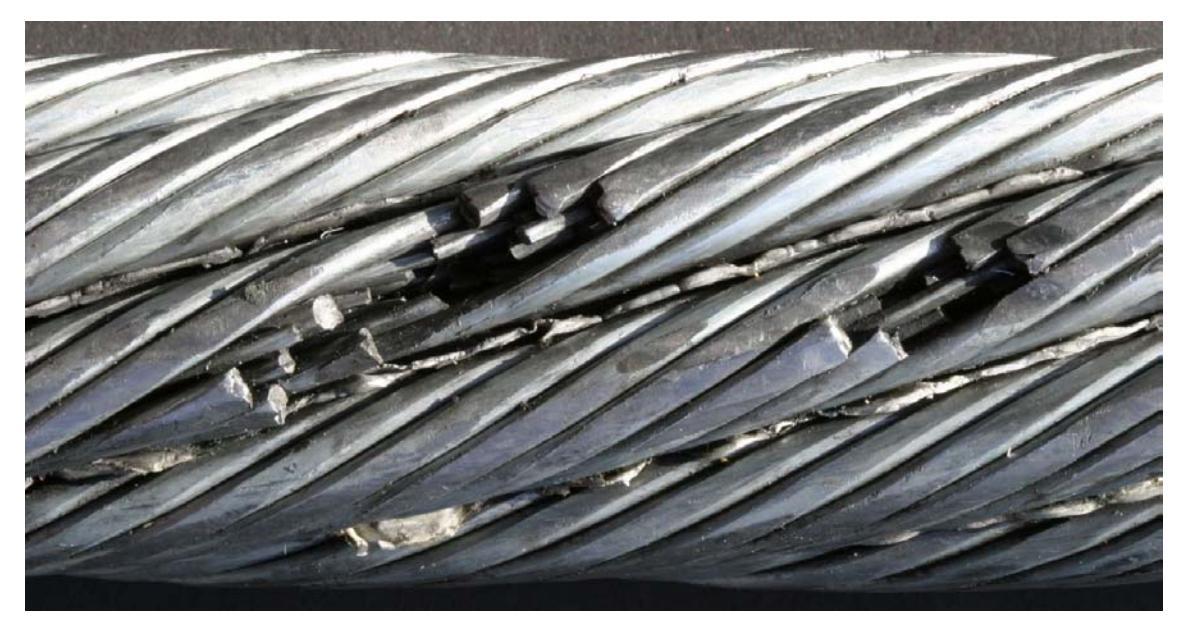
Figure 12: Typical damage found in Section B/B, at discard. Note that wire ends have separated.

An obvious potential driver for the severe damage seen in Section B/B (Figure 12) and to a lesser extent the damage in Section B (Figure 11) is the fact that the drum grooves in those areas were found on all four drum compartments to have a diameter of 44 mm, Figure 17. This anomaly was discovered at the time of installation of the eight-strand ropes in September 2005.

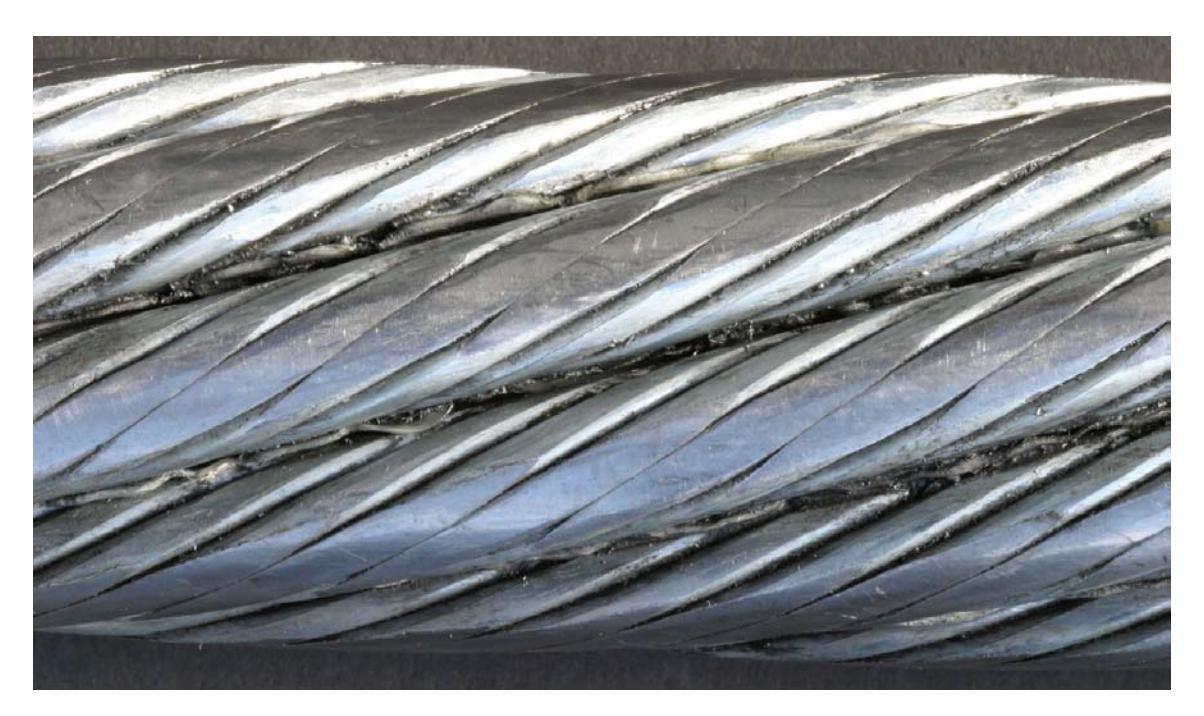
Figure 13: Typical condition of rope in Section C, at discard.

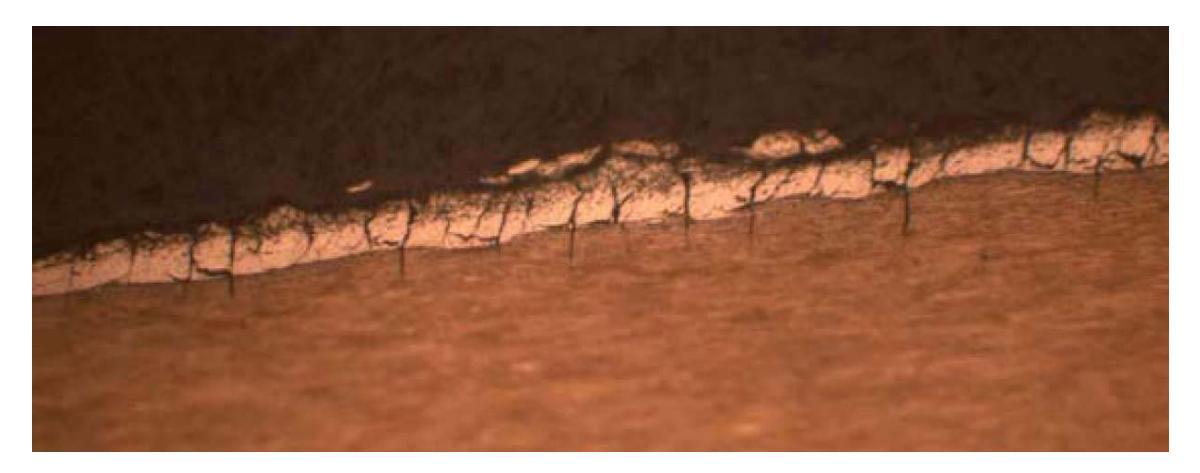
However, it was also found that all other sections of rope including Section C and stock samples of rope held at the rope factory also had cracked delta-layers. Based on this observation the general assumption was that the whole ropes went into service with such delta-layer cracks yet only in Sections A, B and B/B did the delta-layer cracks correspond to cracking in the steel sections of the wires.

Figure 14: Cracking of galvanised layer in Section B/B, circa 400x magnification, [6].

Regarding the issue of delta-layer cracking, it was felt that this may have contributed to the degradation of the rope but as it was present throughout the rope lengths it could not have been the primary driver as wire breaks would then have been found in Section C. Section C, especially the first few turns thereof, sees the same tensile loading and bending as the last few turns of Section B/B. It seemed feasible that there must have been some other factor common to Sections A, B and B/B (which were all in direct contact with the drum) that lead to their degradation. The general nature of the damage was consistent across all four ropes.

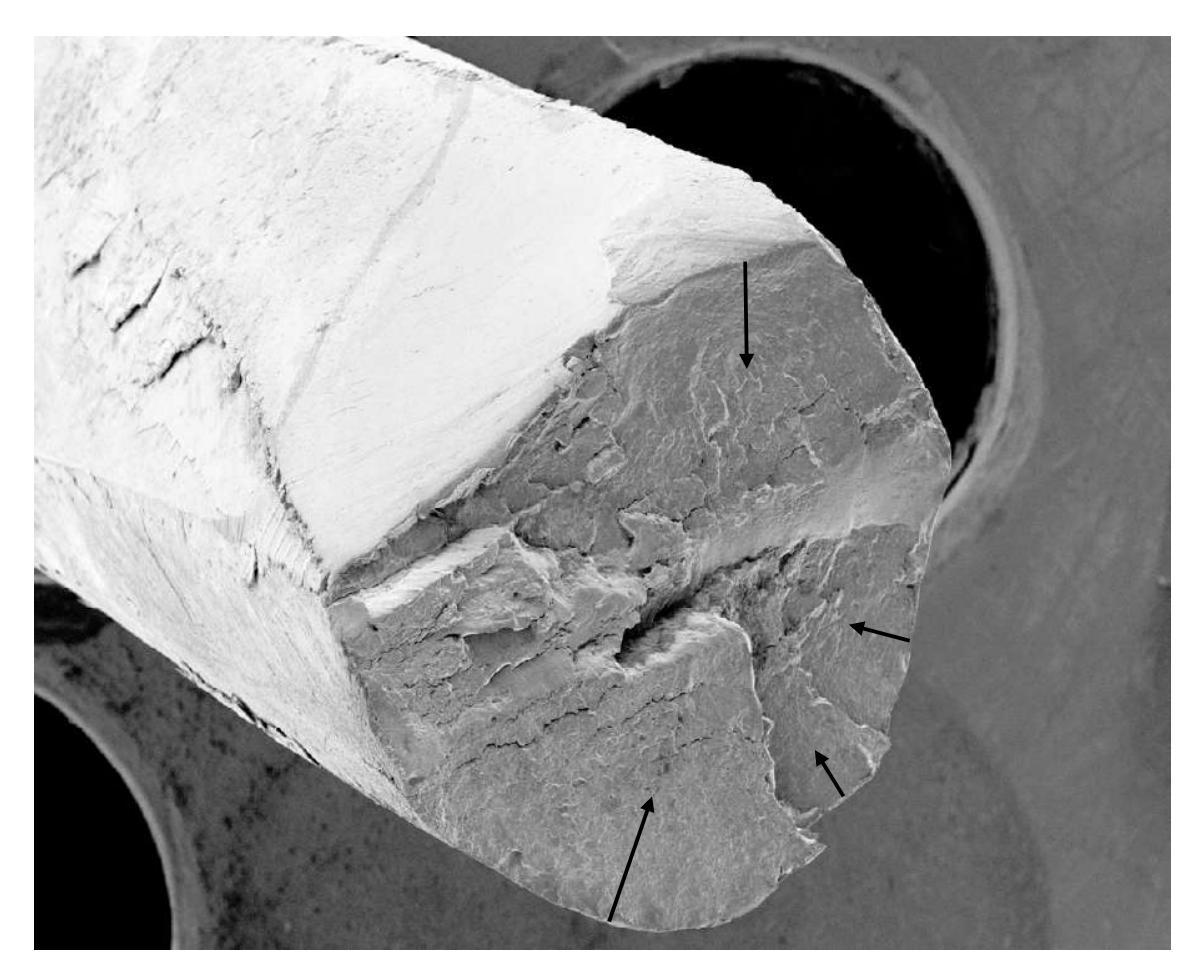
Figures 15 and 16 show typical fracture surfaces of outer and inner wires taken from Section B/B (see also Figures 9 and 12). The general pattern of failure was one of fatigue crack initiation from multiple sites around the wire circumference leading to final fracture in the centre of the wire. This is a typical indication of the rope section having been subjected to high cyclic compressive loads and associated secondary bending of the wires and strands.

Figure 15: Typical fracture surface of outer wire from Section B/B, see also Figure 12. Arrows indicate assumed multiple fatigue crack propagation regions towards central region of final failure. Image supplied by Wire Rope Technology Aachen.

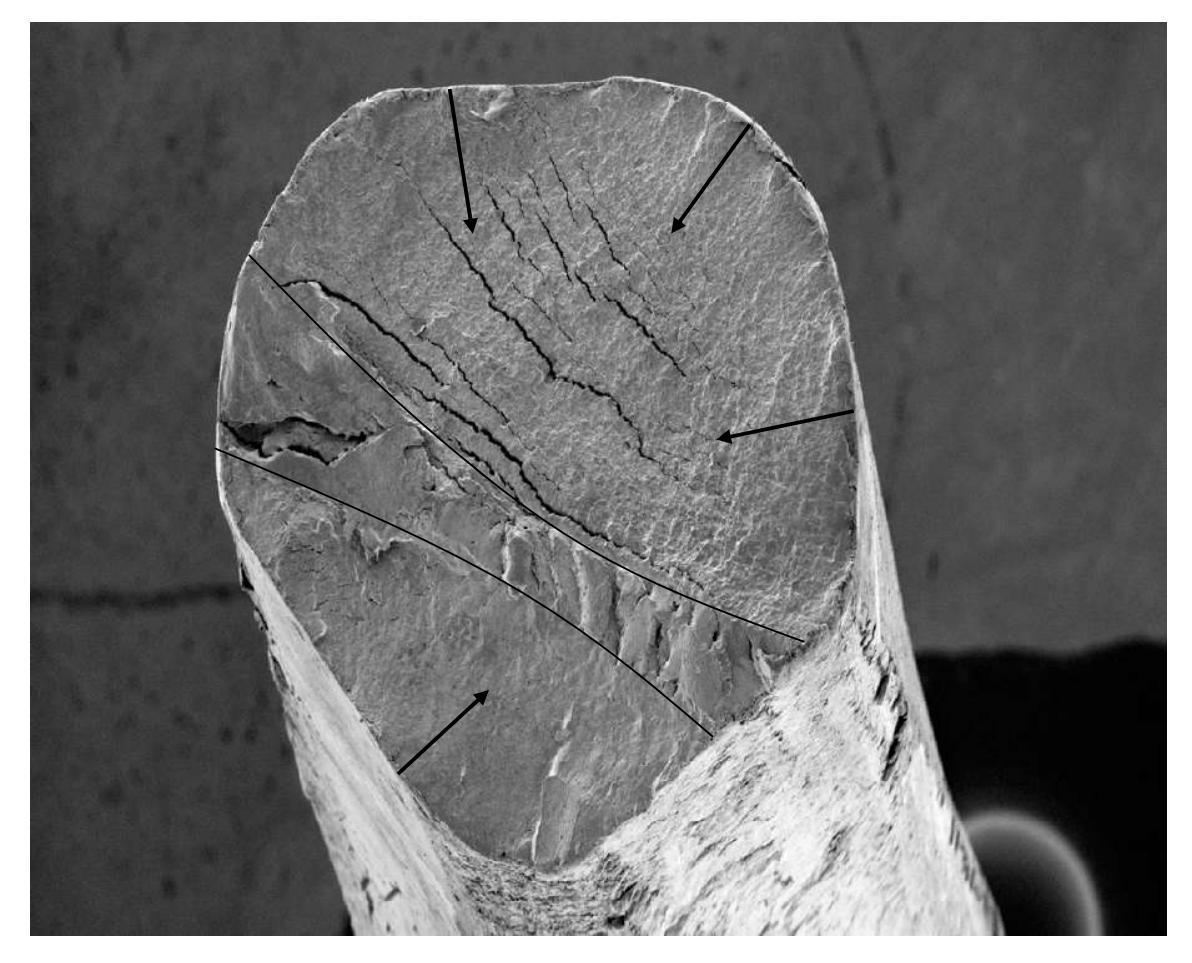
Figure 16: Typical fracture surface of inner wire from Section B/B, see also Figure 12. Arrows indicate assumed fatigue crack propagation regions towards central region of final failure. Note also longitudinal cracking possibly from high transverse loading. Image supplied by Wire Rope Technology Aachen.

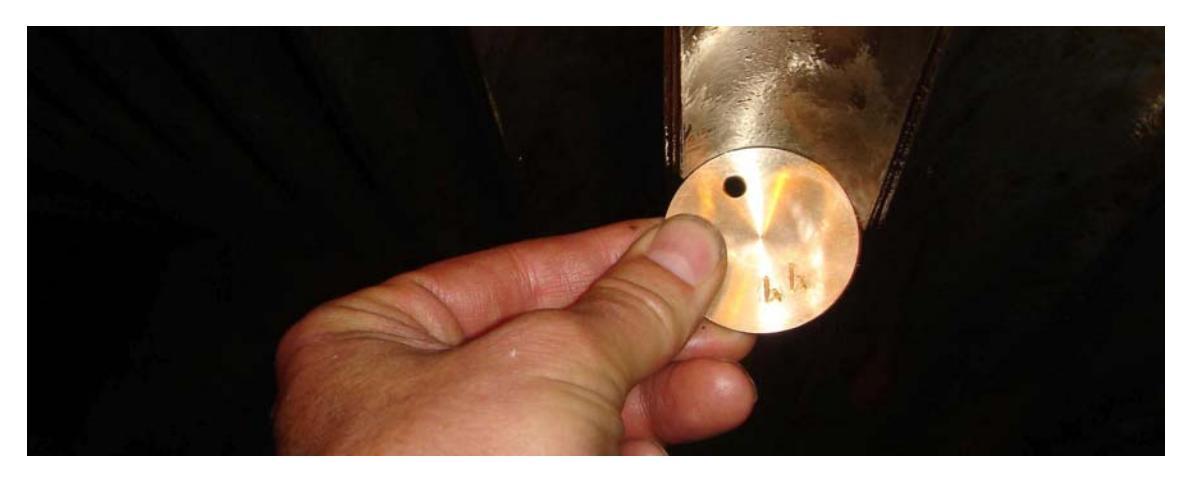
Figure 17: 44 mm drum grooves in Sections B and B/B at installation.

The SANS 10294 code of practice for the performance, operation, testing and maintenance of drum winders relating to rope safety, [2], recommends a mean drum sleeve groove diameter for a nominal 45 mm rope of 48.15 mm and a mean pitch of 47.81 mm (compared to an actual pitch of 46 mm). A 44 mm groove would therefore place significant compressive loads on the rope especially if the rope is manufactured with a tolerance on the nominal diameter of +4%, as was the case with the eight-strand ropes. Figure 18 shows imprints of the rope that are assumed to be a consequence of the tight drum grooves in Section B/B. The photograph was taken on the day that ropes 1 and 2 were discarded. The drum grooves in that region were measured again and were still at 44 mm.

It is critical that the drum LeBus coiling sleeves are measured accurately before finalising the diameter of rope to be ordered for a winder. Even if the same nominal diameter rope has been used on a winder for many years it is still worth checking that the relationship between the actual drum groove geometry and the intended rope diameter match the recommendations of standards such as SANS 10294, [2]. Failure to do this can have a very significant effect on rope life irrespective of the rope construction. Figure 21 shows the typical effect that groove diameter can have on rope life in bending fatigue applications.

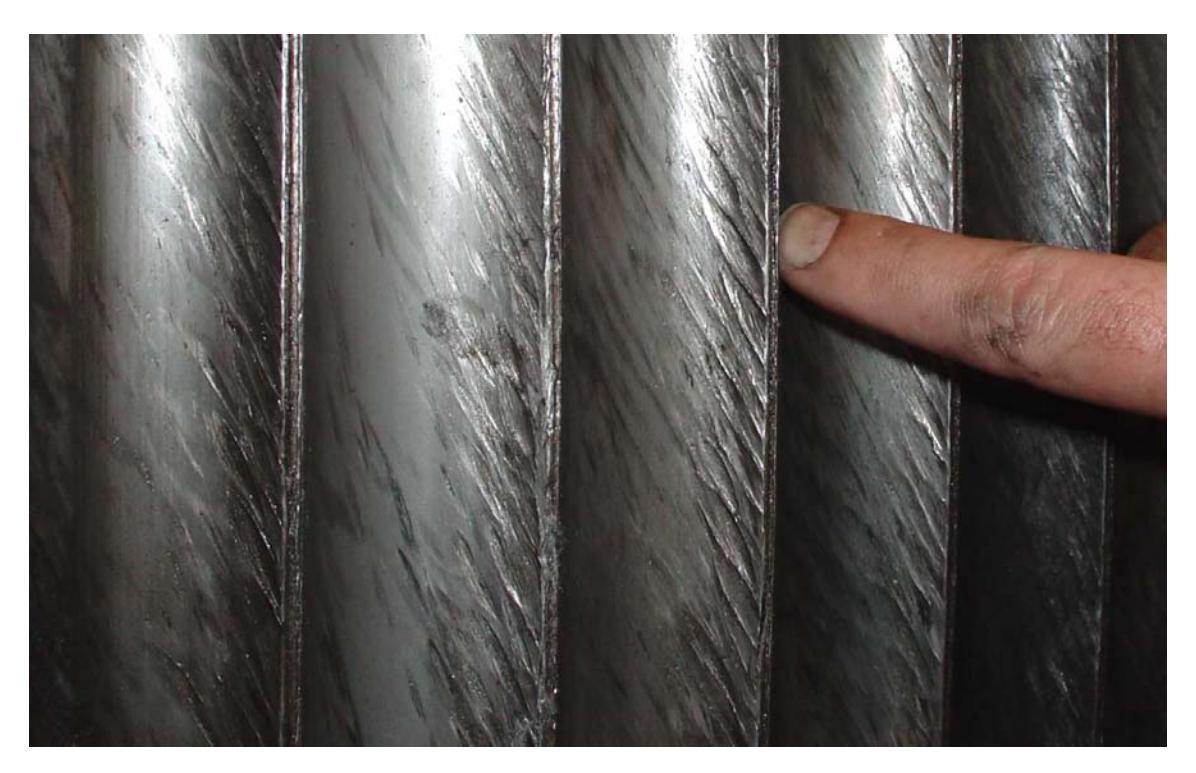
Figure 18: Rope imprints on drum grooves in Section B/B after 35,000 cycles.

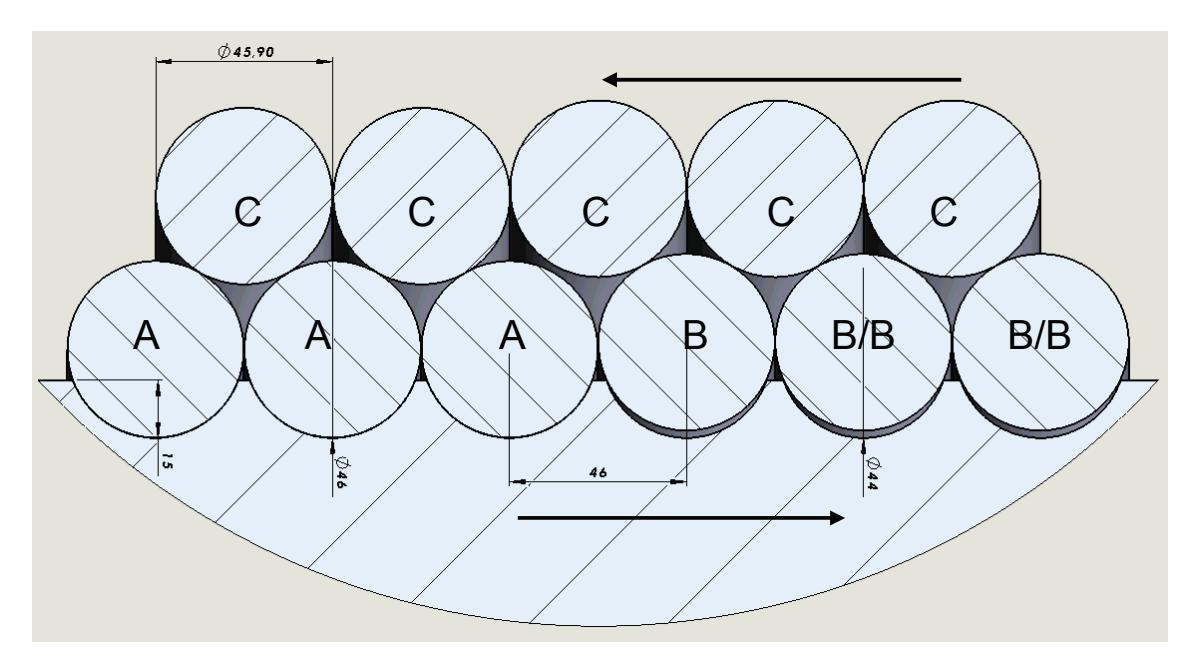
Figure 19: Coiling diameter clearances resulting from undersized grooves on parts of the drums, Sections A and B. The arrows indicate the direction of coiling. Note the coiling clearances in the three 44 mm grooves on the right. Number of turns shown in A, B, B/B and C are for indication of the relative positions only.

It is possible that the tight grooves in the B and B/B areas lead to slackness of rope accumulating in areas A and B. This would explain the rapid deterioration of the ropes in the dead turn regions (A and B). Figure 19 shows the effect that the tight grooves have on the coiling diameter in the 44 mm groove areas. As the upper layers press down on the B/B sections there is a possibility of slackness accumulating which is milked towards B and then A. Even if only a small amount of slackness accumulates every cycle, the sum of this over 1000s of cycles could cause significant problems in both Sections A and B in spite of proper doubling down (Figure 7).

Rope manufacturers and mine winder operators should routinely monitor the development of slackness in the dead turns on drum winders. This is particularly important when using high stiffness ropes like the eight-strand with IWRC construction discussed in this paper. Slackness in the dead turns can be detected either by pinging the dead turns with a hammer and or by painting a line across the dead turns after doubling down. There will be a clear difference in the pinging sound between tight dead turns and slack ones. Additionally, if a horizontal line has been painted across tight dead turns, any movement of the dead turns would become apparent by a change in position of the line. Regular doubling down with full skips is a very effective way of maintaining proper dead turn tension.

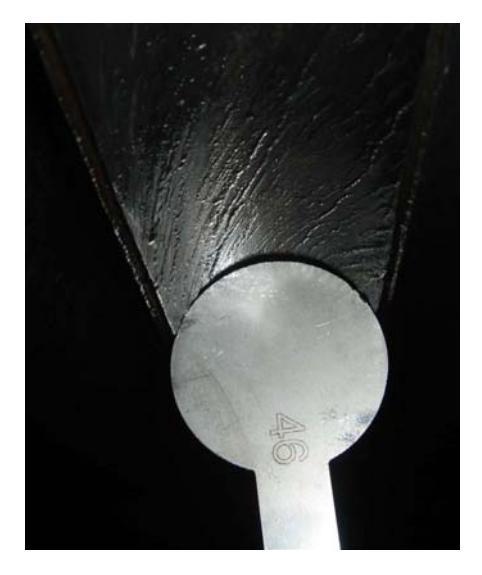
A further illustration of this point is Figure 20 which shows how a rope with an operating diameter of 46 mm would sit initially in the 44 mm drum grooves. The extent of the clearance matches the to-scale drawing in Figure 19. Clearly, as the pressure from the coiling of subsequent layers (up to a total of 4 in the B/B region) increases, the clearance will reduce to zero and cause some slackness in each turn. This slackness in B/B is forced towards B and A by the coiling of C above B/B, see arrows showing the coiling directions in Figures 9 and 19.

Figure 20: 46 mm rope groove gauge in 44 mm drum groove, Section B/B, shortly after installation of the eight-strand ropes.

The winder has been in operation for some 35 years. It is believed that the reason circa half of each drum compartment has 44 mm grooves and the rest 46 mm grooves is that the drums were originally manufactured with 46 mm grooves and pitch and that the triangular strand ropes (which settle with a circa 44 mm operating diameter in the live turn region) machined the 46 mm grooves down to 44 mm over the many years of operation.
