P. Greyling¹, R. Rontgen¹, G. Rebel² and B. Schmitz²

Premature discard of 45 mm ropes operating on a Blair Multi-Rope

rock winder

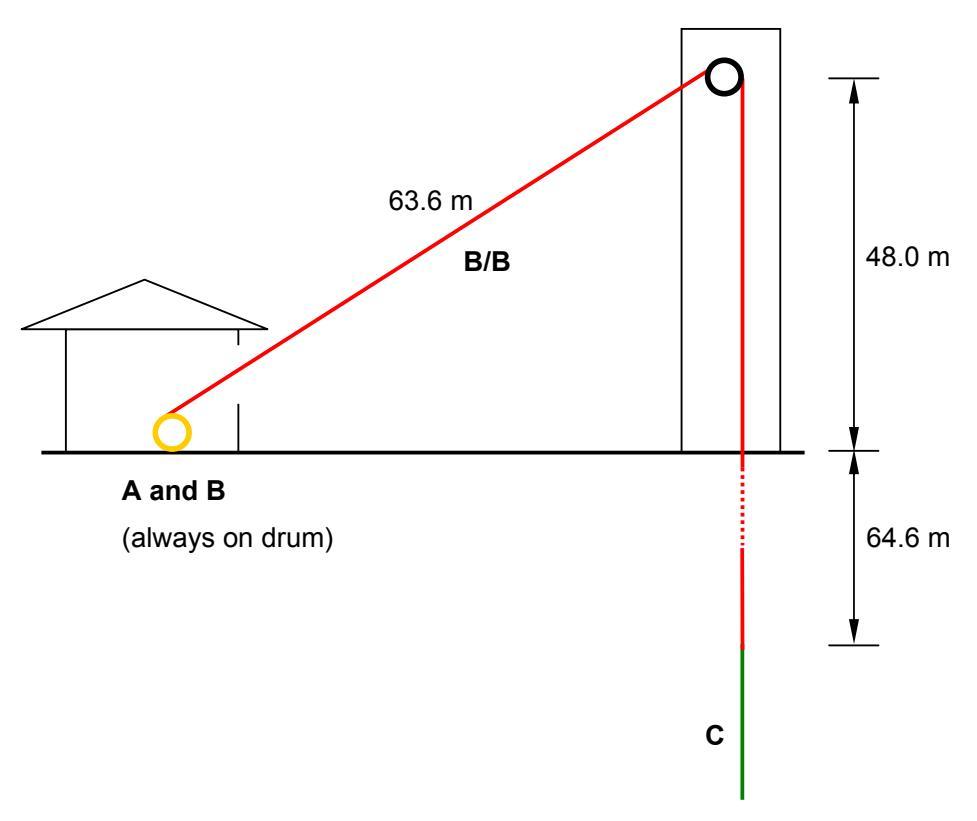
Figure 10 shows Sections A, B, B/B and C relative to the winder and headgear mounted sheaves. The typical levels of local damage found in the sections are shown in Figures 11, 12 and 13. No broken wires were found in samples cut from Section C and this fact was also confirmed by re-examining the NDT test data from the two discard dates of ropes 1 and 2 and 3 and 4.

Figure 10: Rope lengths relative to the BMR winder, headgear sheaves and mine shaft.

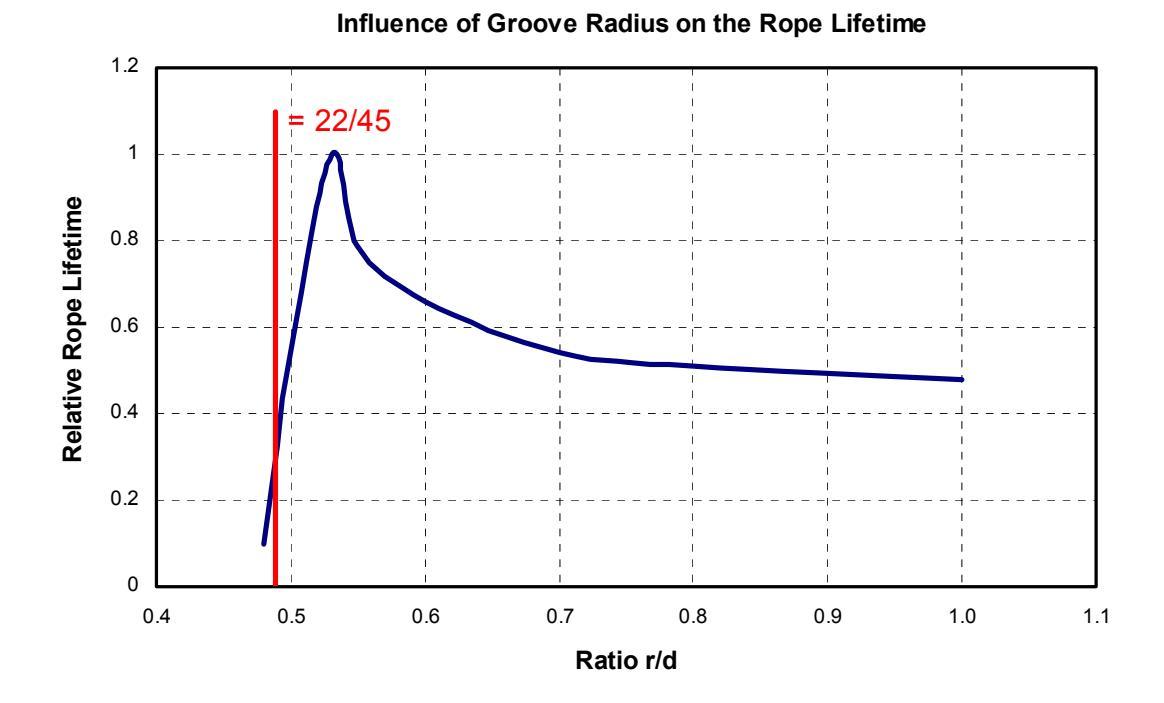
The tight drum grooves in Sections B and B/B are a valid explanation for the damage found in those regions. However, for a rope which settled with an operating diameter of circa 45.90 mm (45 mm + 2%) the tight groove issue is not as problematic in Section A where the measured groove diameter was 46 mm across all four drum compartments. In Section A and to a lesser extent in Section B, see Figure 9, it is thought that accumulation of slackness in these dead turns lead to the wire failures shown earlier in Figure 11. The majority of the broken wires were located at the LeBus half turn crossovers where the dead turns would suffer the most if not adequately tensioned.

Figure 21: Rope life on sheaves for a varying relationship between rope diameter and sheave groove radius. For tight sheaves (i.e. a r/d ratio below 0.53) the rope life drops off dramatically. The vertical line represents a 45 mm nominal diameter rope in a 44 mm groove. Rope life expectation under this condition is circa 30% of the life in a standard sized groove.

It is critical that the drum LeBus coiling sleeves are measured accurately before finalising the diameter of rope to be ordered for a winder. Even if the same nominal diameter rope has been used on a winder for many years it is still worth checking that the relationship between the actual drum groove geometry and the intended rope diameter match the recommendations of standards such as SANS 10294, [2]. Failure to do this can have a very significant effect on rope life irrespective of the rope construction. Figure 21 shows the typical effect that groove diameter can have on rope life in bending fatigue applications.
